Eradication of salvinia (*Salvinia molesta*) from the Adelaide River, Northern Territory

I. L. Miller and S. E. Pickering

Summary

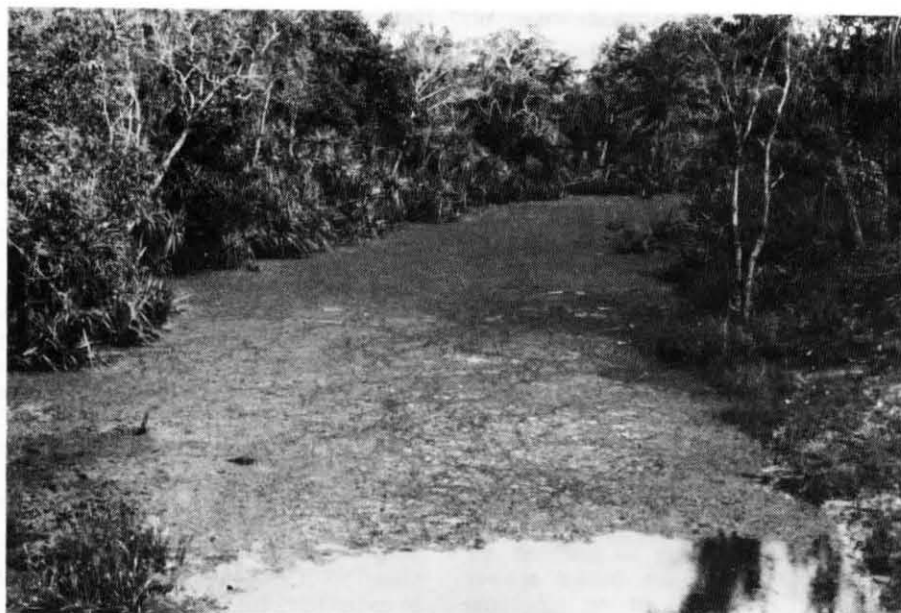
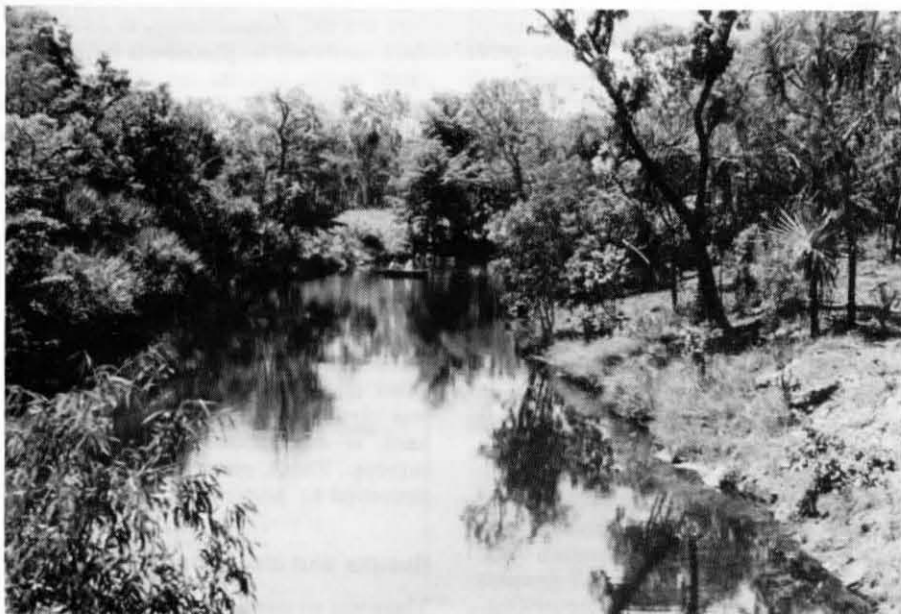
Figure 3 (a) 'Mat-form' salvinia on pool 1 of the Adelaide River, 10 January 1977. (b) The same area free of salvinia, 25 September 1980.

There was an intensive control effort during the first two months of 1977. The first spraying in pool 1 with paraquat and diquat on 12 January caused chlorosis and necrosis of exposed leaf surfaces within 1 week but was not sufficient to kill the mat. This result was similar to the impact made on Tinaroo Falls Dam, Qld, where paraquat and diquat produced only superficial browning (Julian 1978). Salvinia leaves in mats are compressed and deeply folded; hence the inner parts of the plant are protected from contact herbicides. It was not until after four sprayings at weekly intervals with paraquat/diquat and paraquat/diquat/2,4-D, that the mat lost buoyancy and sank. This occurred between 4 and 11 February. Pool 1 and channel 1 were virtually clear by 24 February, this being the last date that salvinia was detected in those areas (Figure 3).
